Letter Report No. 103257316COQ-001D

Subject: Findings Report 103257316COQ-001D

Intertek has conducted weathering tests for Cadillac Coatings Canada Inc. on various coated panels. The Cadillac Coatings Canada Inc. panels were tested for freeze/thaw resistance and ultraviolet light exposure. Freeze/thaw resistance was conducted in accordance with the client's test specifications. Ten (10) cycles were conducted where each cycle consisted of 20 hours of freezing at -35 ± 5°C and 4 hours of thawing at 23 ± 5°C. Ultraviolet light exposure was conducted in accordance with ASTM G155-13, Standard Practice for Operating Xenon Arc Light Apparatus for Exposure of Non-Metallic Materials, Cycle 1 (102 min light at 63°C black panel temperature, 18 min light and water spray) for a total of 3000 hours. Samples were received at the Evaluation Center on November 29, 2017 (Coquitlam ID# VAN1712131529-001). Testing has been completed and results can be found in Table 1 below.

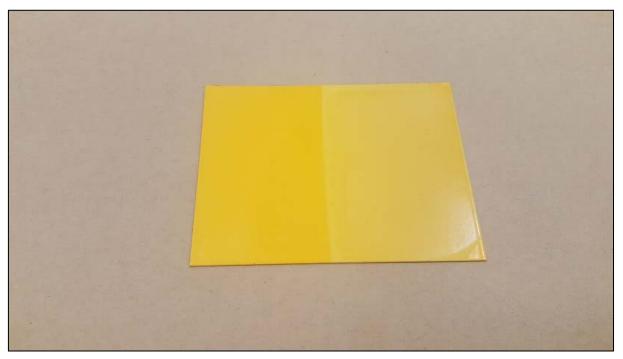
Figure 1. #130 (Control Left Side & Weathered Right Side)

Table 1. Test Results	
Property	Test Result
Ultraviolet Light Exposure (3000 hours)	Slight fading and/or discoloration for all specimens; refer to photos in Appendix A
Freeze/Thaw Resistance (10 cycles)	No sign of any change after 10 cycles

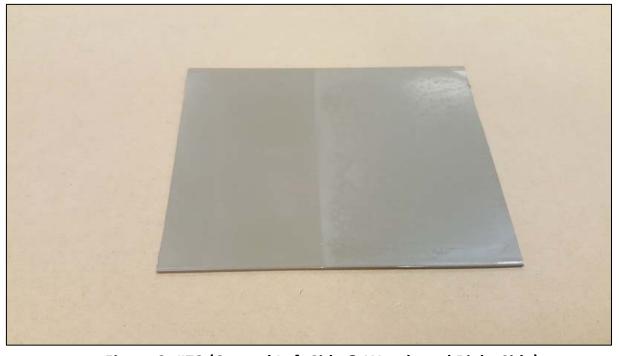
Figure 2. #78 (Control Left Side & Weathered Right Side)

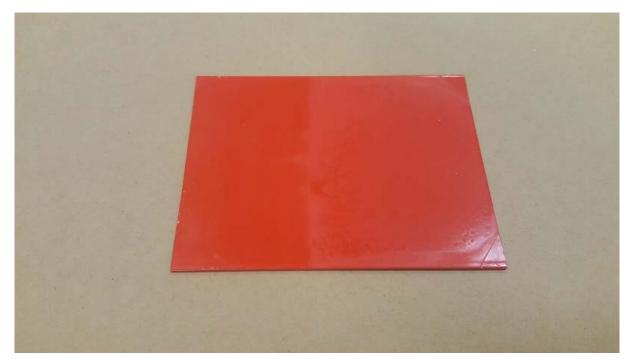
Figure 3. #84 (Control Left Side & Weathered Right Side)

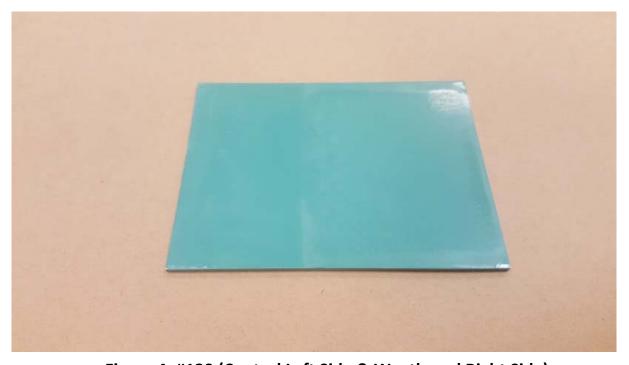
Figure 4. #129 (Control Left Side & Weathered Right Side)

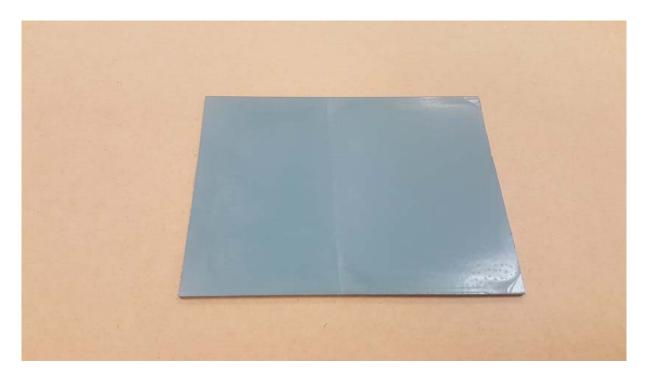
Figure 5. #122 (Control Left Side & Weathered Right Side)

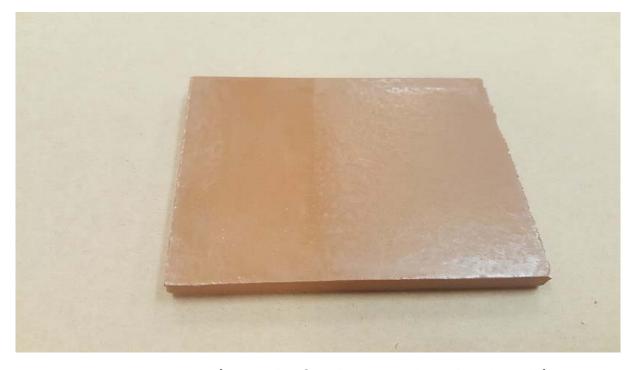
Figure 6. #71 (Control Left Side & Weathered Right Side)

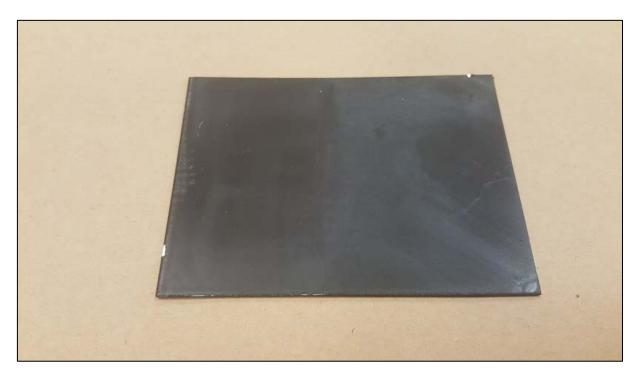
Figure 7. #98 (Control Left Side & Weathered Right Side)

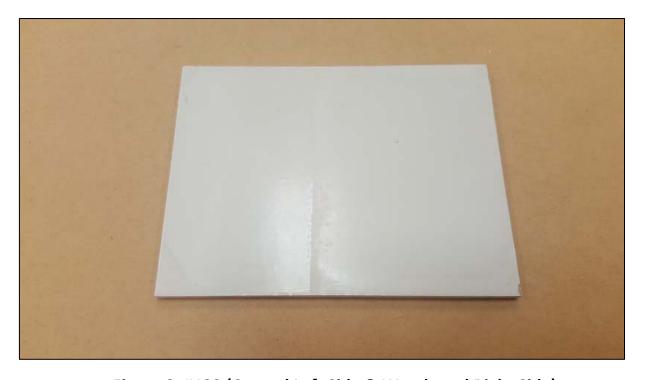
Figure 8. #133 (Control Left Side & Weathered Right Side)

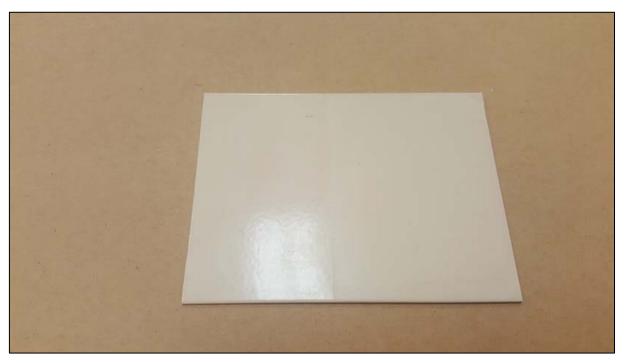
Figure 9. #109 (Control Left Side & Weathered Right Side)

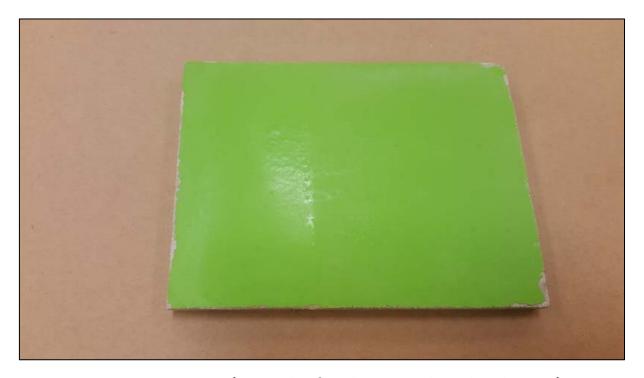
Figure 10. #106 (Control Left Side & Weathered Right Side)
